# Tree Management Plan 2020 - 2025

## Askerswell Millennium Green

Management plan completed by Ian Geddes of Toller Tree Care Ltd

June 2020

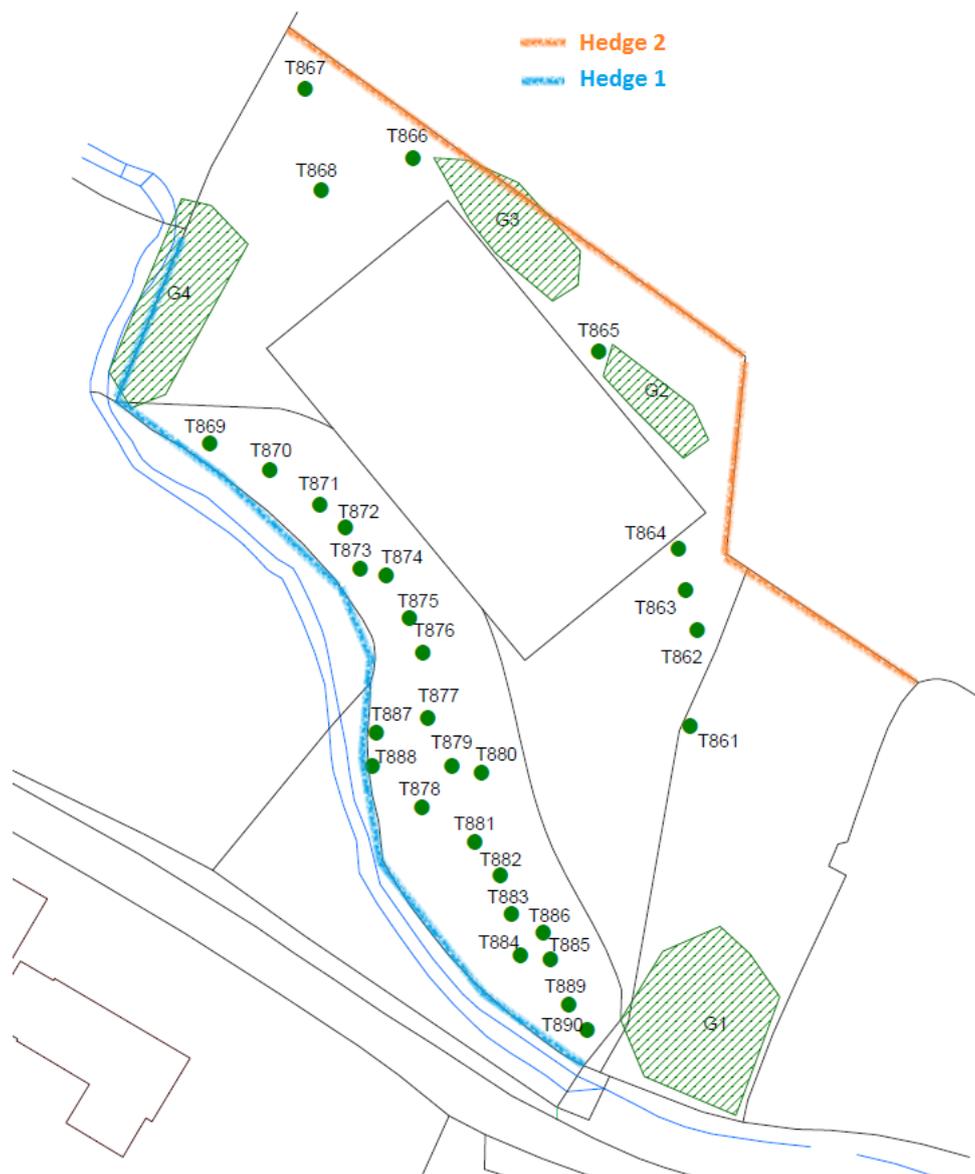
<b>Table 1</b>			
<b>Year</b>	<b>Task</b>	<b>Basic description</b>	<b>Volunteers or contractors?</b>
<b>1</b>	A: Oak 865	Formative prune by removal of lowest secondary leader.	Volunteers or contractor
	B: Oak 868	Crown lift by removing two-three lowest limbs with squirrel damage.	Volunteers or contractor
	C: G2	Removal of closest Alder to Oak 865	Volunteers or contractor
	D: G3	Removal of one-two Alders growing closest to Oak 868	Volunteers or contractor
	E: Hedge 1	River clearing and hedge laying. Removal of 887 and 888.	Volunteers or contractor
	F: G1	Coppice Willow closest to entrance	Volunteers or contractor
<b>2</b>	G: Alder coppicing	Coppicing down to stool level of 1-2 Alders	Contractor
	Hedge 1	Hedge trimming as described in 1.6	Volunteers
<b>3</b>	H: G1	Coppicing of remaining Willow	Volunteers or contractor
	Hedge 1	Hedge trimming as described in 1.6	Volunteers
<b>4</b>	I: Hedge 2	Hedge laying and old fence removal.	Volunteers or contractor

<b>5</b>	Hedge 2	Hedge trimming as described in 1.6	Volunteers
	J: Sycamore 867	Consider removal if the tree is competing with Oak 868	Contractor
	K: G1	Coppicing one of the two Hazels	Volunteers or Contractor
	L: Alder coppicing	Coppicing a further 1-2 stools.	Contractor

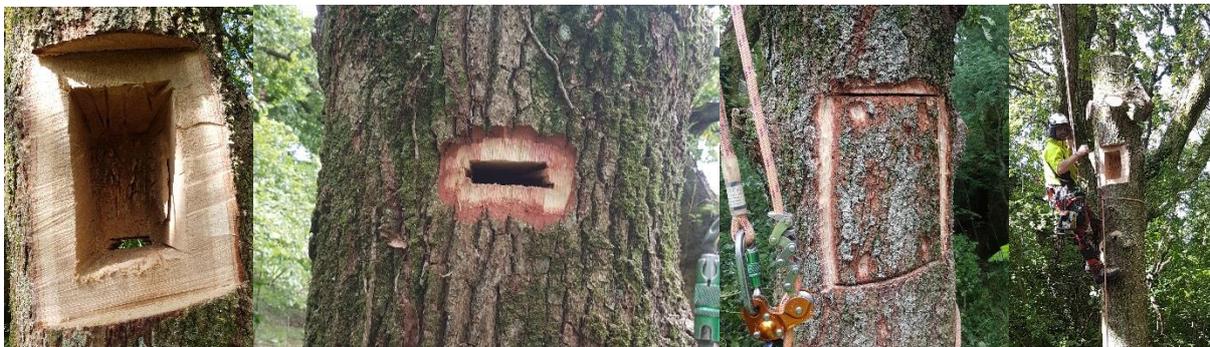
The Alders make up a large proportion of the trees on the site, these are all a similar age and have most likely been coppiced in the past. The decision of what trees are to be coppiced should be based on their condition at the time and the information on the Tree Risk Assessment. This work will allow some of the larger trees to have wider crowns and to create a varied age range in the future.

It could also be worth creating some standing dead monoliths for habitat if the trees that are selected lend themselves to this. They will need to be in low use areas, not too tall and they can be added to the annual inspection list to assess their stability. These could provide great habitat for bats, birds and invertebrates. Monoliths could be enhanced with the addition of further habitat creation as in the images below. Artificial cracks made in the trunks with a chainsaw make for great potential bat habitat and smaller nest cavities for birds. This work is most likely only able to be carried out by contractors and would cost £450 - £680.
